Manhole Inspection Summary

Manhole # S29I__033MH

Location Address: **631 W. Pratt St**

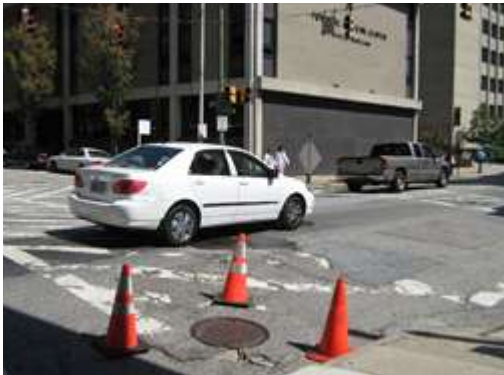
Location View

631 W Pratt

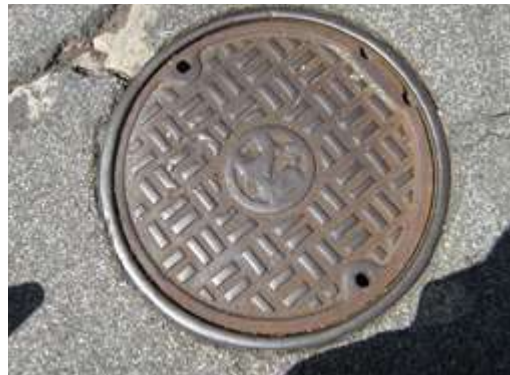
Cover View

Condition: **Broken**

cover worn

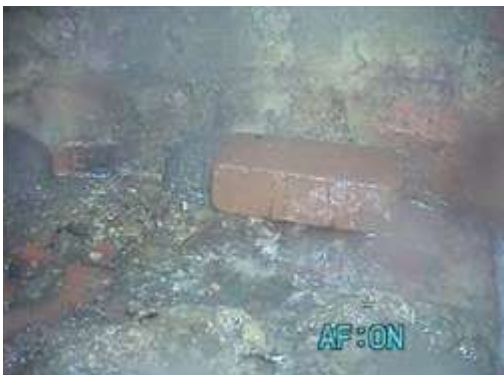
Defect 3

Debris on bench

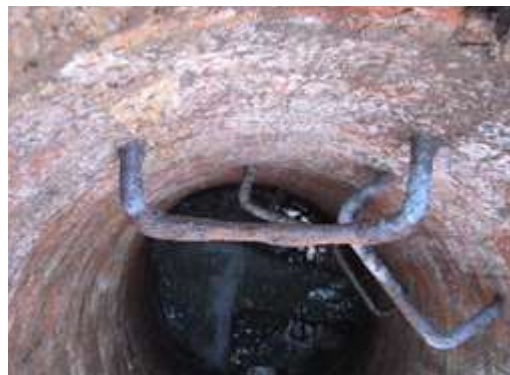
Defect 2

Count: **8** Missing: **0** ☒ **Corroded**

corroded rungs

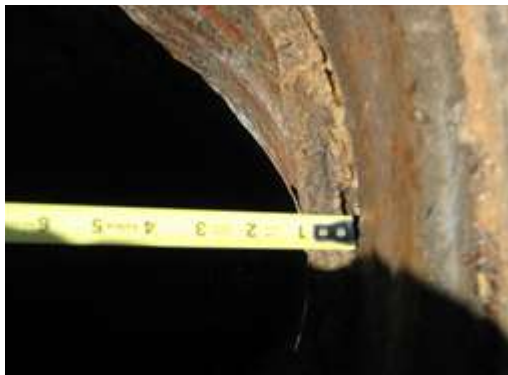
Defect 1

Offset: **1** (in.)

Off set 1"

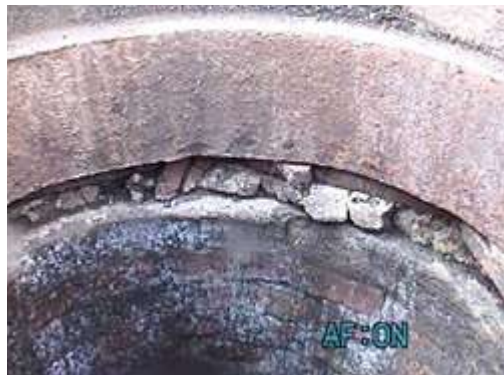
Condition: ☐ Sound ☐ Cracked ☐ Root Intrusion ☒ **Loose Brick** ☒ **Deteriorated**

Infiltration: ☐ None ☐ Joint ☐ Cracks ☐ Mortar ☐ Roots ☒ **Wall**

Loose bricks and mortar in chimney,
chimney and corbel infiltration

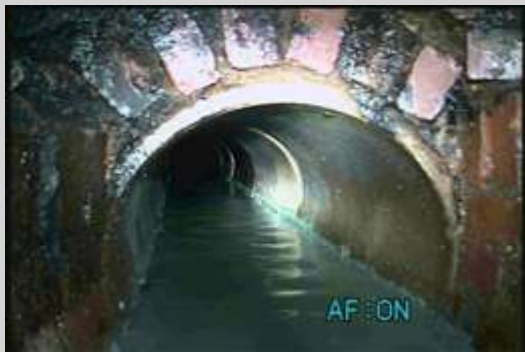
12 O'Clock Outflow

15 in. Circular Gravity Sewer
Pipe Out @ 12 O'Clock

Pipe Height: **15.6** (in.) Rod and Bar (Angled)
Pipe Material: **Clay** ☐ Pipe Lined
Invert Depth: **13.60** (ft.) Flow Characteristics: **Turbulent**
Deposits: ☒ None ☐ Mud ☐ Sludge ☐ Debris ☐ Grease
Silt Depth: **0** (in.) Deposits Extent:
Infiltration: **None** Pipe Seal Cond: **Sound**

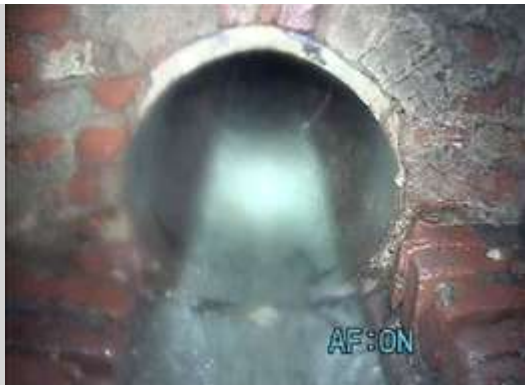
5 O'Clock Inflow

15 in. Circular Gravity Sewer
Pipe In @ 5 O'Clock

Pipe Height: **15.6** (in.) Rod and Bar (Angled)
Pipe Material: **Clay** ☐ Pipe Lined
Invert Depth: **12.97** (ft.) Flow Characteristics: **Turbulent**
Deposits: ☒ None ☐ Mud ☐ Sludge ☐ Debris ☐ Grease
Silt Depth: **0** (in.) Deposits Extent:
Infiltration: **None** Pipe Seal Cond: **Sound**

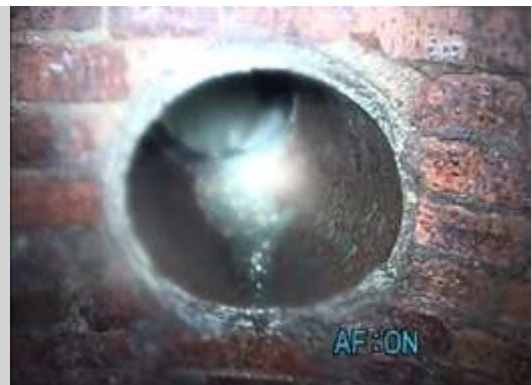
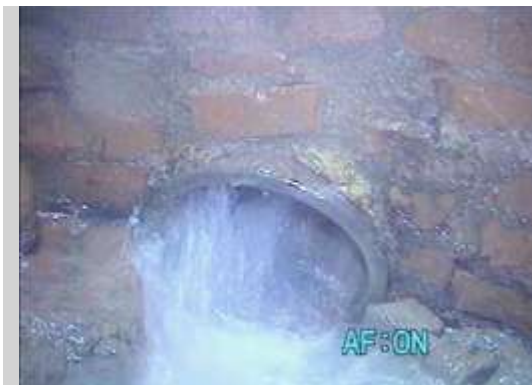
10 O'Clock Inflow

10 in. Circular Gravity Sewer
Pipe In @ 10 OClock

Drop In @ 10 OClock

Pipe Height: **10.8** (in.) Rod and Bar (Angled)
Pipe Material: **Clay** ☐ Pipe Lined
Invert Depth: **10.41** (ft.) Flow Characteristics: **Turbulent**
Deposits: ☒ None ☐ Mud ☐ Sludge ☐ Debris ☐ Grease
Silt Depth: **0** (in.) Deposits Extent:
Infiltration: **None** Pipe Seal Cond: **Sound**

Drop: Inside	Rod and Bar
Angled: Yes	Reading: 12.24 (ft.)
	Inv Depth: 13.24 (ft.)
Drop Condition: Open	
Connects To: Manhole	
<input type="checkbox"/> Possible Illicit Connection
